Figure 4: Monitoring Well Locations & Groundwater Quality Exceedances

| Figure 3 Site Map Site Name Site Address Site City, State | | |

Figure 3
Groundwater Contour Map
 Site Name
 Site Address
 Site City, State

| FIGURE 3: BTEX & LNAPL DISTRIBUTION | | |

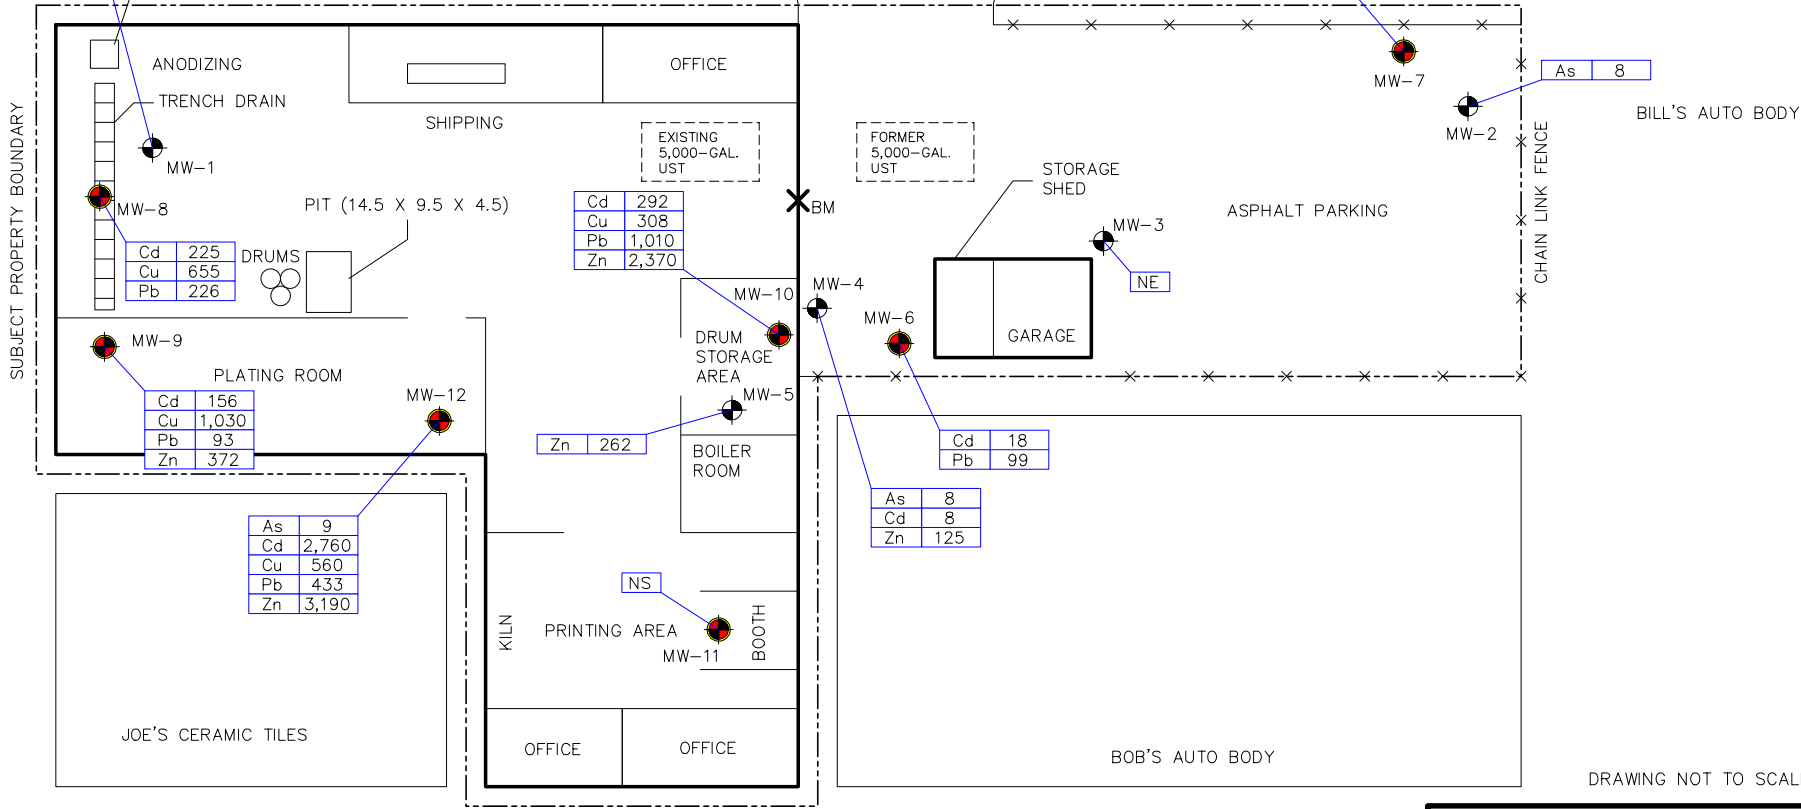
- PHASE II SOIL BORING W/TEMPORARY MONITORING WELL (6/9 & 6/10/05)
- PHASE III SOIL BORING W/PERMANENT MONITORING WELL (10/24 & 10/25/05)
- BENCHMARK
- NE NO EXCEEDANCES (ALL VALUES IN UG/L)
- NS NOT SAMPLED

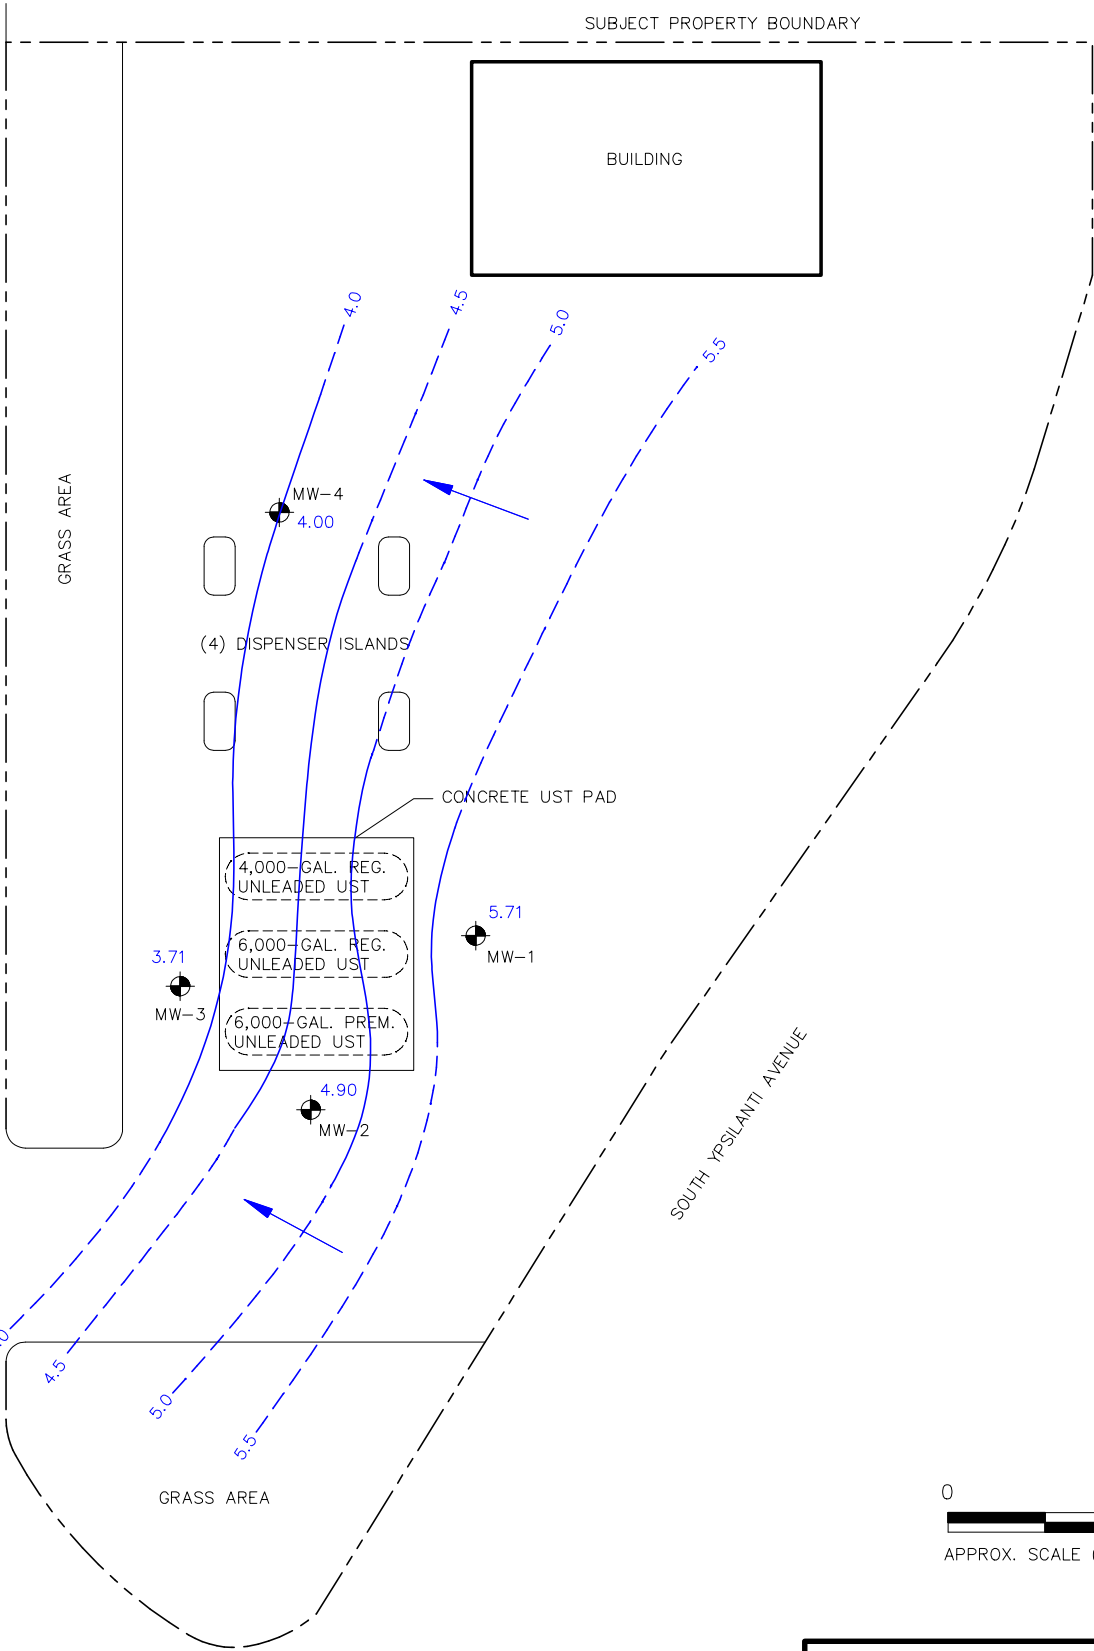
MONITORING WELL LOCATION
- 5.71

WATER TABLE ELEVATION (FEET)
- 5.5

WATER TABLE CONTOUR (FEET)
-

GROUNDWATER FLOW DIRECTION

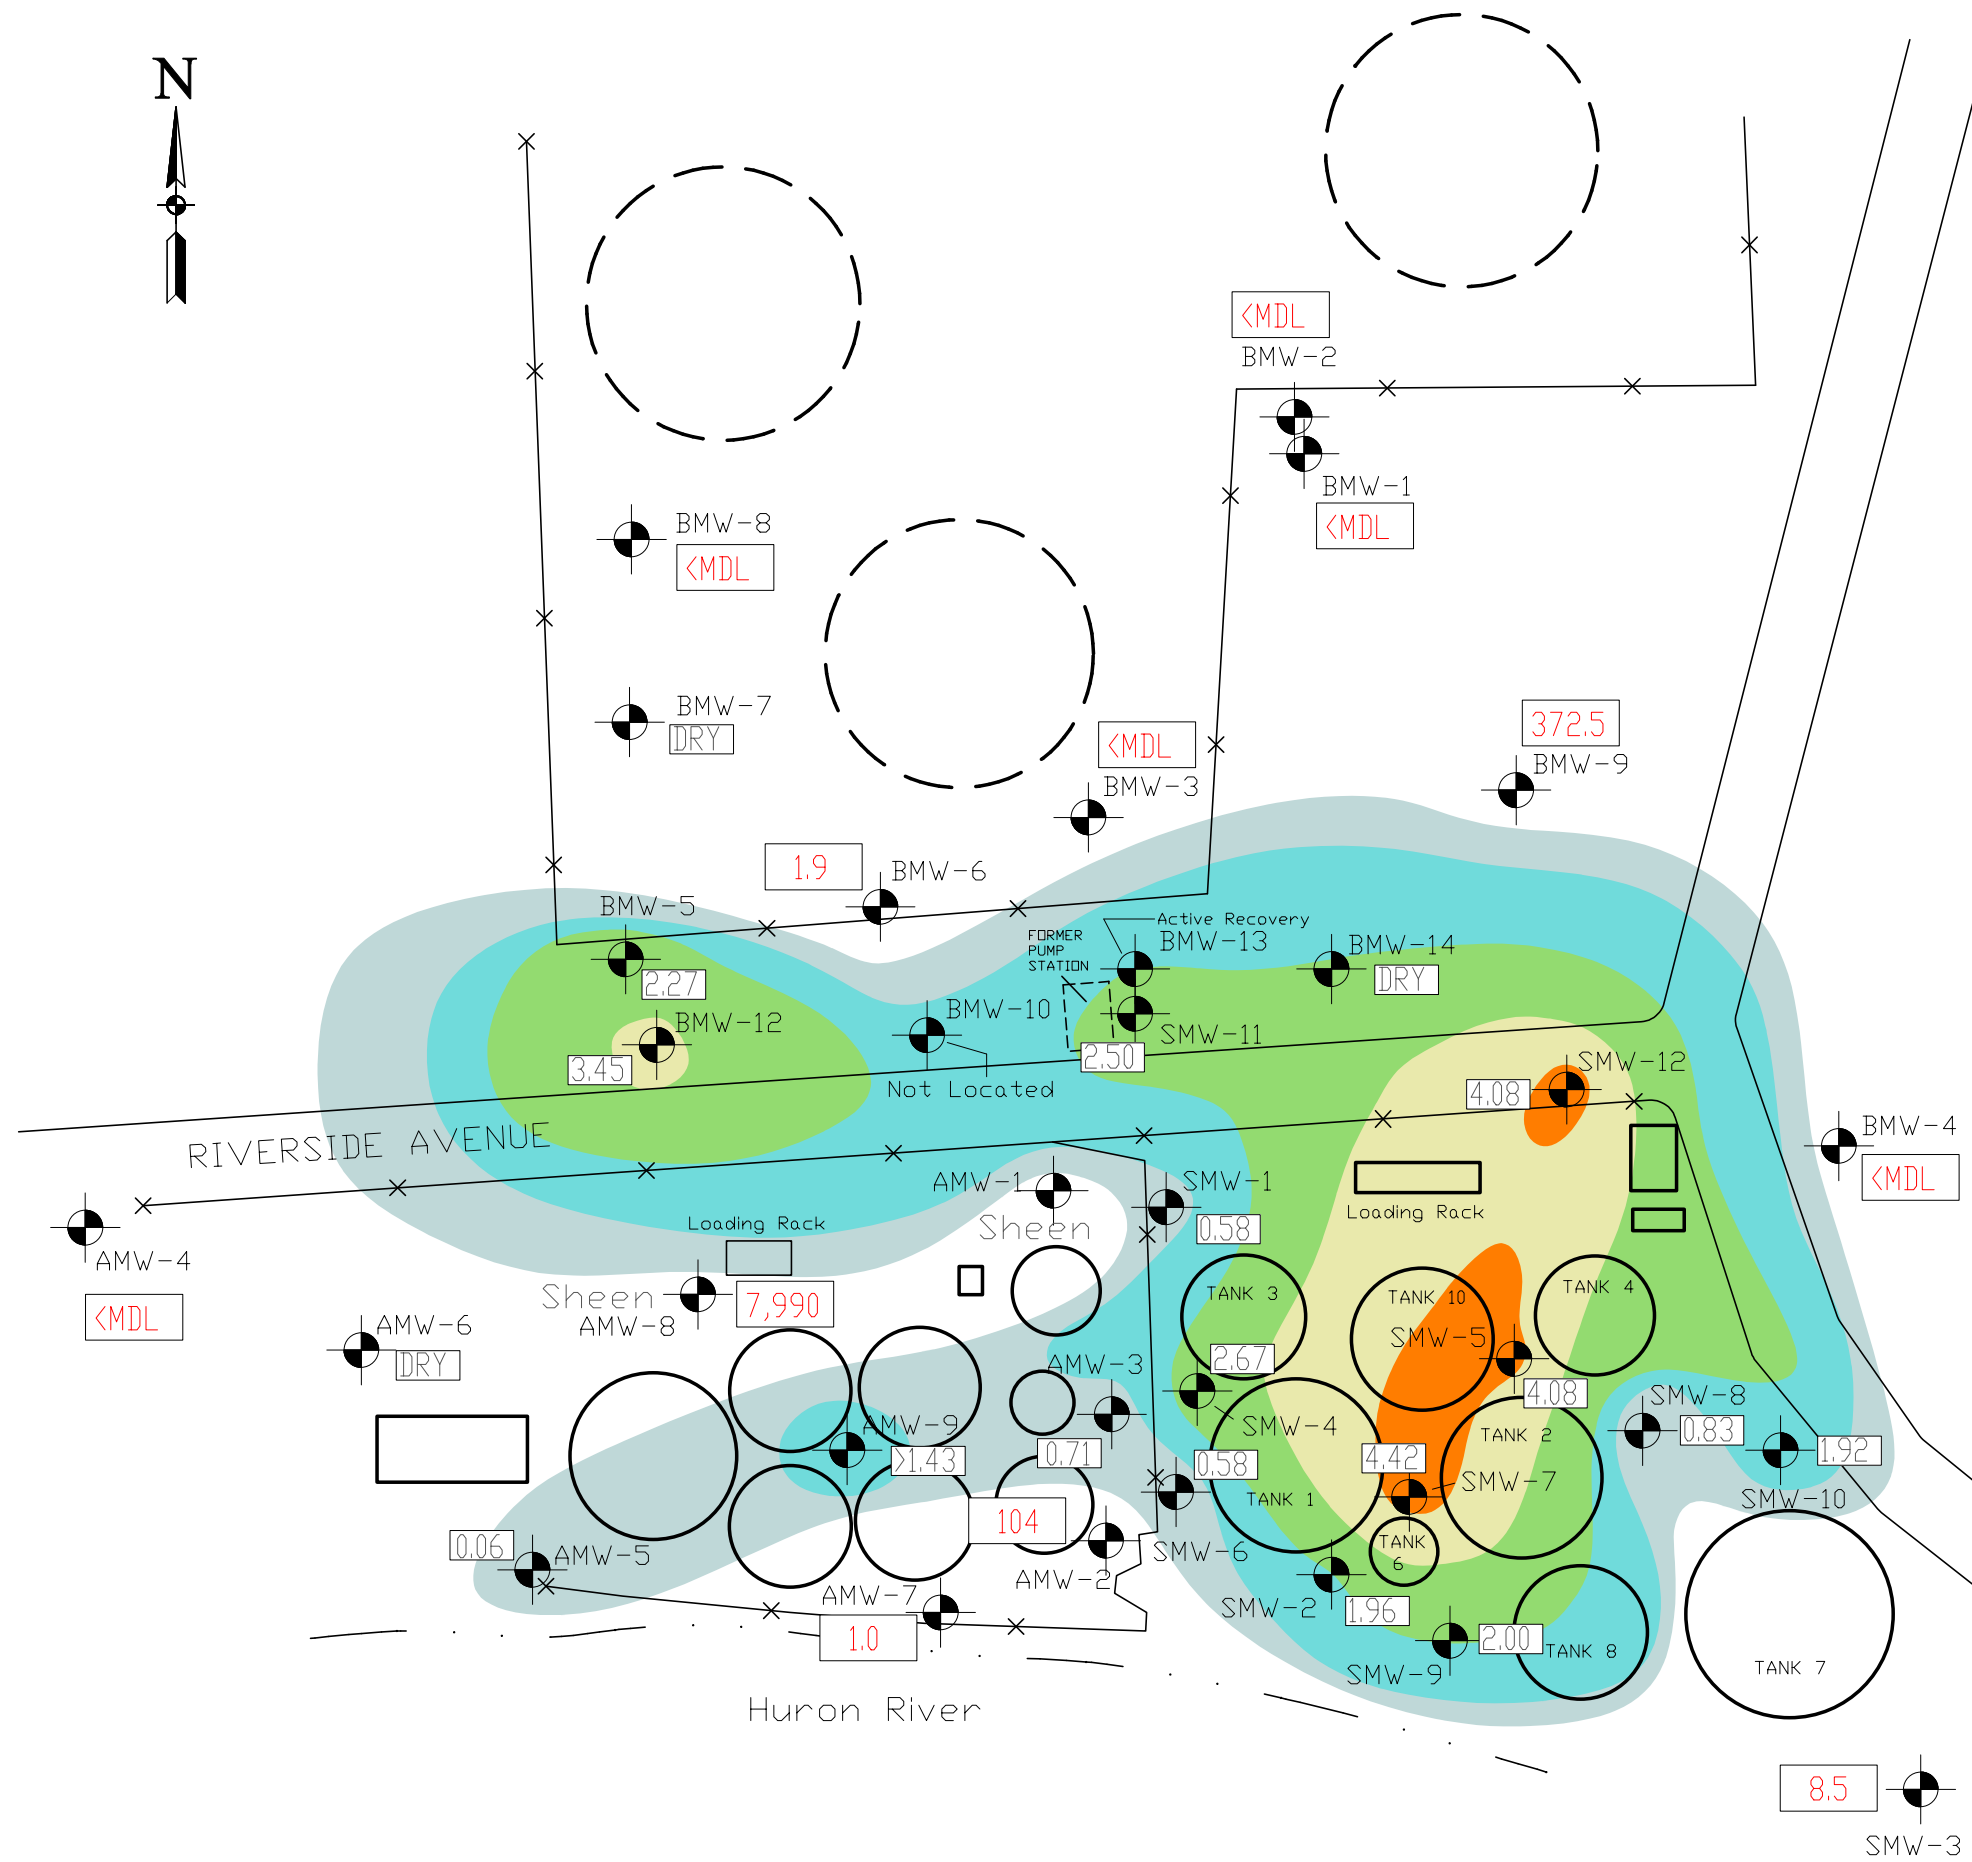
372.5 BENZENE, TOLUENE, ETHYLBENZENE AND XYLENES (UG/L)
-

4.08 APPARENT LNAPL THICKNESS (FEET)
-
